Contract #: 04-0120F4Cty: SF/ALA Rte: 80 PM: 13.2/13.9File #: 69.28**WELDING INSPECTION REPORT****Resident Engineer:**Pursell, Gary**Address:** 333 Burma Road**City:** Oakland, CA 94607**Report No:** WIR-013350**Date Inspected:** 29-Mar-2010**Project Name:** SAS Superstructure**OSM Arrival Time:** 700**Prime Contractor:** American Bridge/Fluor Enterprises, a JV**OSM Departure Time:** 1900**Contractor:** Zhenhua Port Machinery Company, Ltd (ZPMC), Changxing Island **Location:** Shanghai, China**CWI Name:** Zhou Cheng/Chen Xi/Sun Bo**CWI Present:** Yes No**Inspected CWI report:** Yes No N/A**Rod Oven in Use:** Yes No N/A**Electrode to specification:** Yes No N/A**Weld Procedures Followed:** Yes No N/A**Qualified Welders:** Yes No N/A**Verified Joint Fit-up:** Yes No N/A**Approved Drawings:** Yes No N/A**Approved WPS:** Yes No N/A**Delayed / Cancelled:** Yes No N/A**Bridge No:** 34-0006**Component:** OBG Components**Summary of Items Observed:**

Segment 9AE

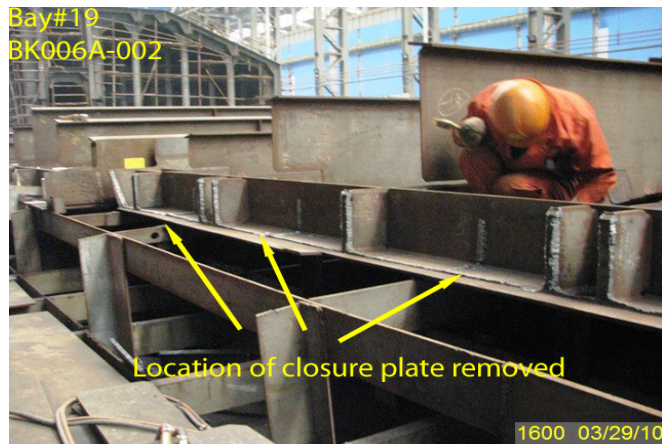
Bay#19

During random in process inspection of Bike Path, BK6A, this QA inspector observed following issue. ZPMC personal performed carbon arc gouging of the parts of BK006A-002. According to fit up procedure ZPMC personal remove the weld of the closure plate and interior diaphragm plates and longitudinal stiffeners from bike path. After removing the parts ZPMC personal performed grinding to make smooth surface. ZPMC personal will performed MT for surface cracks detection because of cutting the welds. The removed parts are identified as: For further information, please see the attached pictures below.

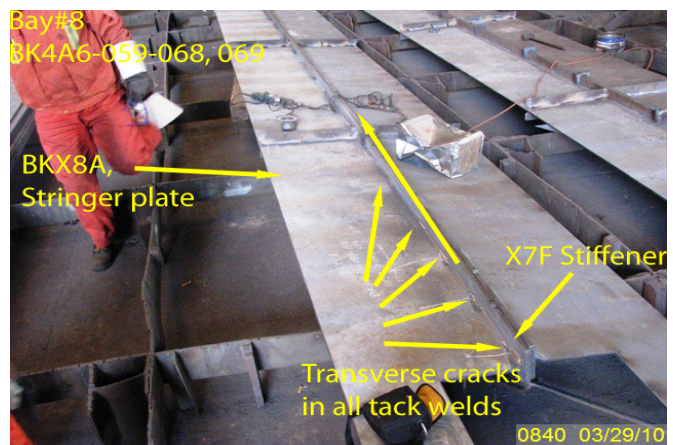
Bay#8

During random in process inspection of Bike Path, BK4A, this QA inspector observed the transverse cracks in tack welds. The weld is fillet weld joining stringer plate to X7F stiffener. The tack welds were made by FCAW welding process. ZPMC personal removed all the cracked tack welds and re welded by SMAW welding process. The weld

s having cracked tack welds were identified as:

BK004A6-059-068, 069- BKX8A stringer plate to X7F stiffener

BK004A6-058-112, 113- BKX9A stringer plate to X7F stiffener

BK004A6-055-068, 069- BKX8A stringer plate to X7F stiffener

BK004A6-056-068, 069- BKX8A stringer plate to X7F stiffener

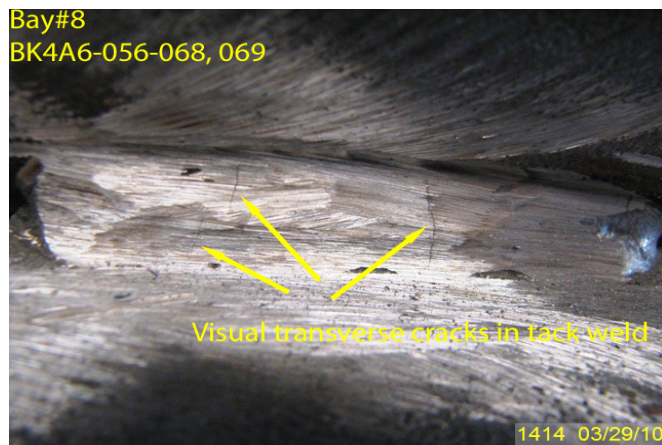
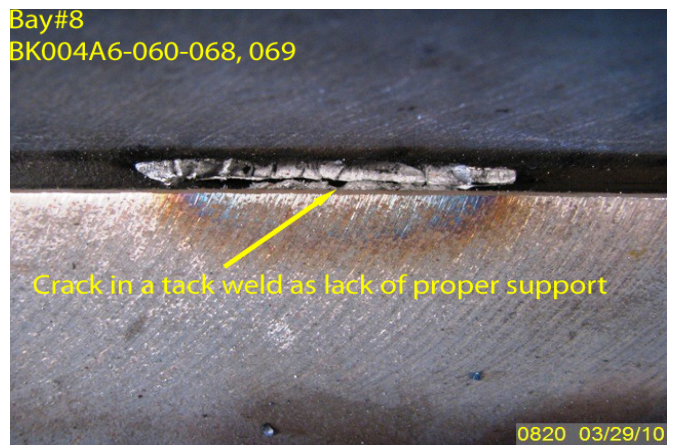
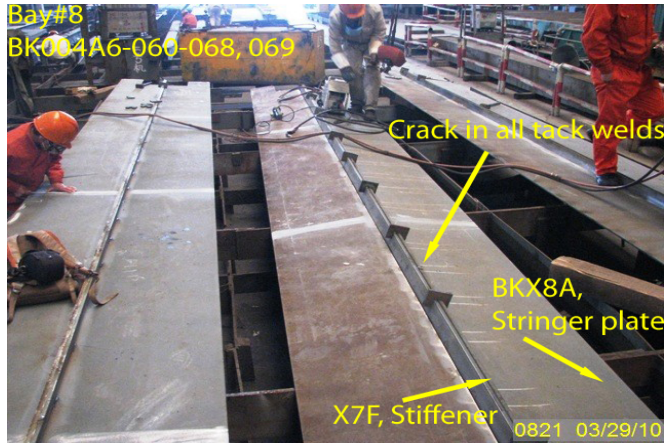
Bay#8

During random in process inspection of bike path BK004A6-060-068, 069, this QA inspector observed that the stringer plate BKX8A had been tack welded with X7F stiffener and was not properly supported. ZPMC personal has to use proper support to prevent tack weld cracking. This QA inspector observed all the tack welds were cracked from the members joining BKX8A to X7F as a lack of proper support. ZPMC personal has to remove all the crack tack welds and perform MT inspection before welding the new tack welds.
